Manhole Inspection Summary

Manhole # S35M__037MH

Insp Date: **3/24/08 9:06 AM**

Location Address: **600 light st**

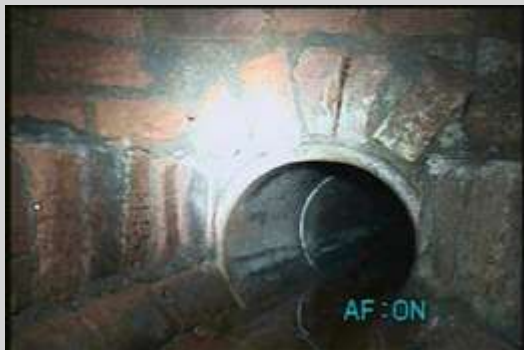
12 O'Clock Outflow

8 in. Circular Gravity Sewer
Pipe Out @ 12 O'Clock

Pipe Material: **Clay** ☐ Pipe Lined

Invert Depth: **13.63** (ft.) Flow Characteristics: **Fast**

Infiltration: **None** Pipe Seal Cond: **Unknown**

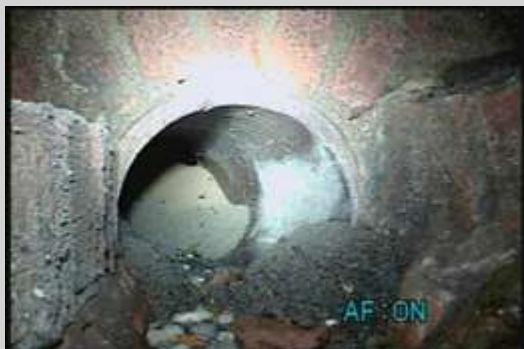
4 O'Clock Inflow

8 in. Circular Gravity Sewer
Pipe In @ 4 O'Clock

Pipe Material: **Clay** ☐ Pipe Lined

Invert Depth: **13.58** (ft.) Flow Characteristics: **None**

Infiltration: **None** Pipe Seal Cond: **Unknown**

Connects To: **Dead End**

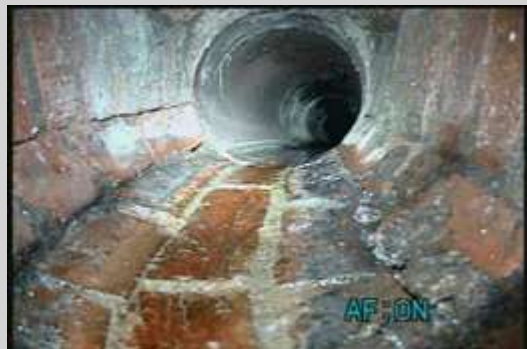
6 O'Clock Inflow

8 in. Circular Gravity Sewer
Pipe In @ 6 O'Clock

Pipe Material: **Clay** ☐ Pipe Lined

Infiltration: **None** Pipe Seal Cond: **Unknown**
